DEPARTMENT OF TRANSPORTATION

Contract #: 04-0120F4Cty: SF/ALA Rte: 80 PM: 13.2/13.9File #: 1.28**WELDING INSPECTION REPORT****Resident Engineer:**Siegenthaler, Peter**Address:** 333 Burma Road**City:** Oakland, CA 94607**Report No:** WIR-017452**Date Inspected:** 12-Oct-2010**Project Name:** SAS Superstructure**OSM Arrival Time:** 700**Prime Contractor:** American Bridge/Fluor Enterprises, a JV**OSM Departure Time:** 1530**Contractor:** American Bridge/Fluor Enterprises, a JV**Location:** Jobsite**CWI Name:** See below**CWI Present:** Yes No**Inspected CWI report:** Yes No N/A**Rod Oven in Use:** Yes No N/A**Electrode to specification:** Yes No N/A**Weld Procedures Followed:** Yes No N/A**Qualified Welders:** Yes No N/A**Verified Joint Fit-up:** Yes No N/A**Approved Drawings:** Yes No N/A**Approved WPS:** Yes No N/A**Delayed / Cancelled:** Yes No N/A**Bridge No:** 34-0006**Component:** SAS OBG**Summary of Items Observed:**

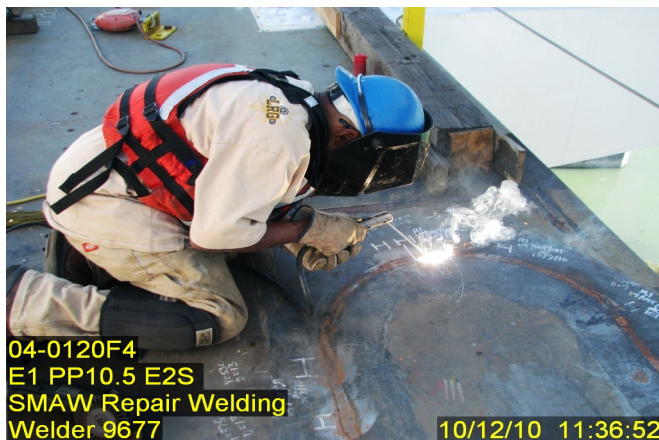
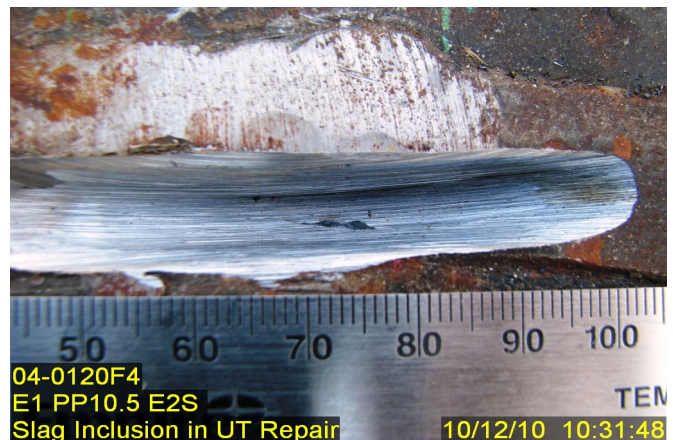
The QAI periodically observed AB/F approved welder Darcel Jackson (ID 9677) performing grinding to excavate an R-1 repair located at Y = 1100mm. The QAI periodically observed QC Inspector Pat Swain performing Magnetic Particle Testing (MT) of the excavated UT repair areas prior to welding. The excavated area when approximately 11 mm in depth was observed by the QAI to contain an approximately 8mm long indication that appeared to be a slag inclusion. See photo below. The QAI also observed that the MT of the excavation was performed at several intervals and revealed that the indication although gradually reducing in length was not fully removed until an excavation depth of 18mm. The final excavation dimensions were as follows: Y = 1045, Length = 100mm, Width = 18mm and the depth = 19mm. The QAI observed that the performance and evaluation of the MT appeared to comply with the MT procedure identified as SE-MT-CT-D1.5-101 Rev. 4. The QAI periodically observed AB/F approved welder Darcel Jackson (ID 9677) performing repair welding of the excavated area (R-1) at E1 PP10.5 E2S per the Shielded Metal Arc Welding (SMAW) process. See photo below. QC Inspector Pat Swain was present to monitor the progress and verify that the welding parameters were within the limits established by the approved welding Procedure Specification (WPS) identified as ABF-WPS-D1.5-1001-Repair. The repair welding was completed at this location during the QA Inspectors shift and the work appeared to be in general compliance with contract documents.
